Docket No. 217 – Development and Management Plan Inspection

Date: September 7, 2005

Location: Norwalk Substation Expansion

Location: Plumtree Substation Expansion, Bethel

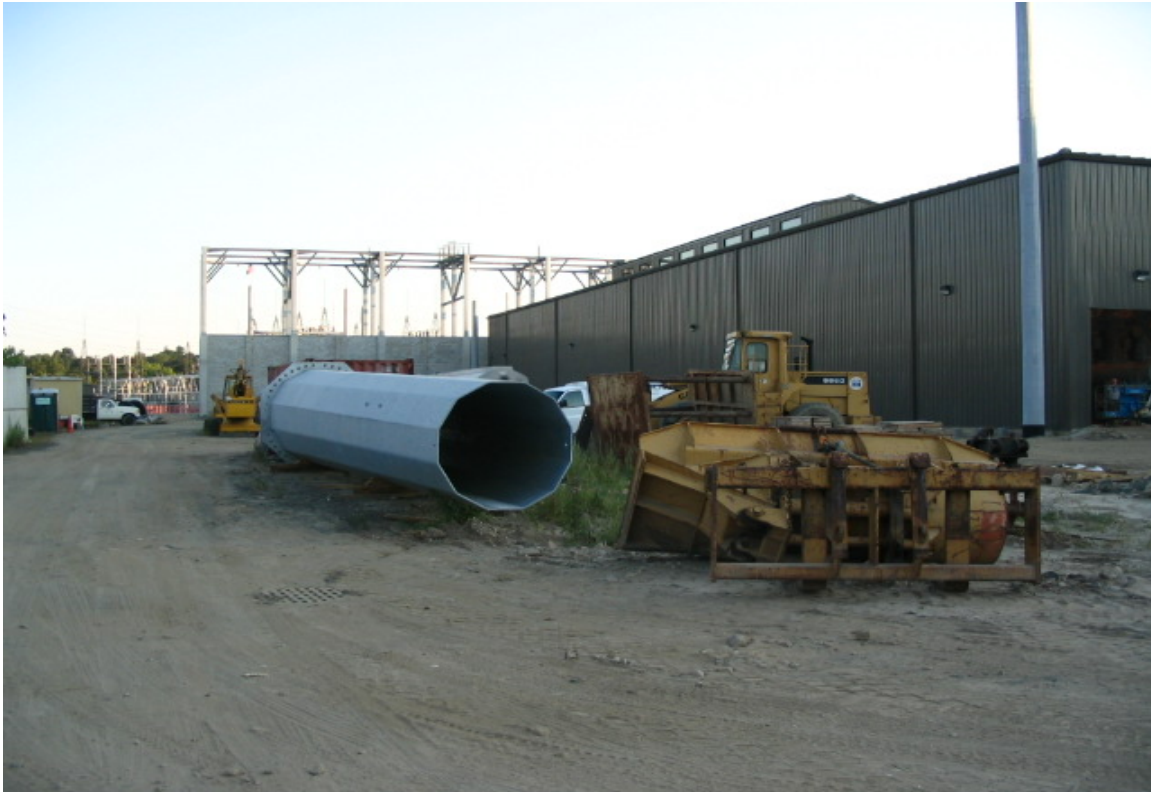
Norwalk Substation: General overview of the GIS building and yard with some of the stockpiled equipment. (9/7/05)

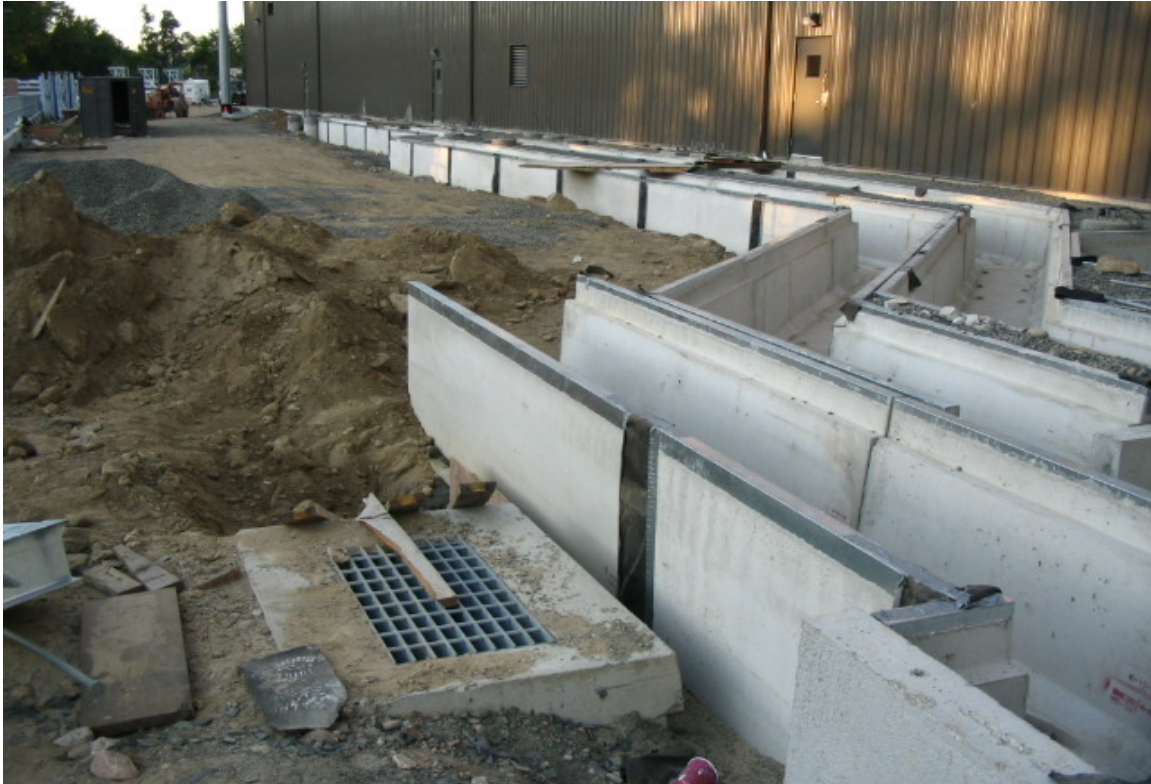
View of the ongoing conduit tray/trench installation along the side of the GIS building. (9/7/05)

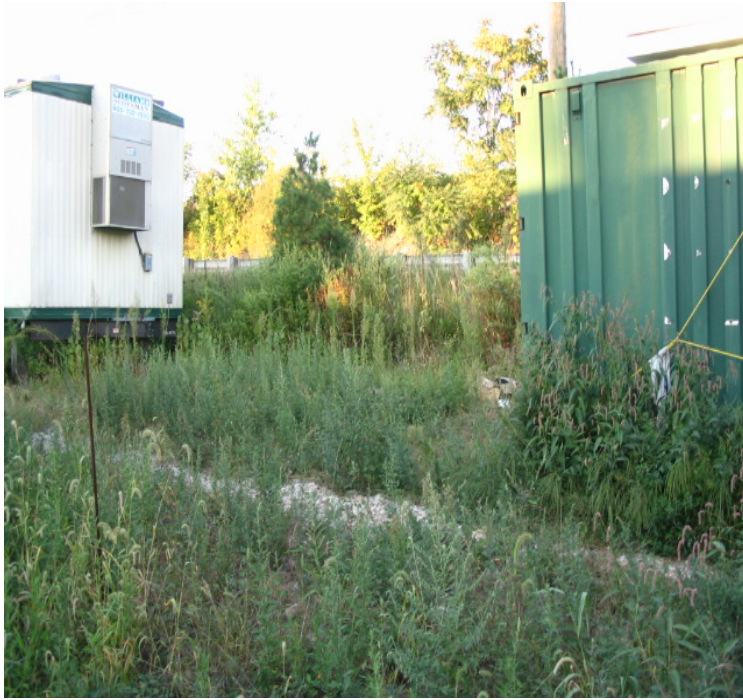
Areas of Inspection	Observation	Recommended Action
Spills and Material Storage continued	- The piles of debris noted outside of the perimeter fence and adjacent to the Rt. 7 ramp have been picked up as recommended. 9/7/05	- Report spills to the office immediately, even if they are being controlled. - Take care not to get carried away and to be vigilant when refueling. - All fuels and agents not in use should be covered and stored in the sheds and trailers before leaving for the day.
Additional Observations

Photo on the left shows that the material piled near the Rt. 7 ramp has been removed. Photo on the right shows that the swale and area along the perimeter fence are very well vegetated. (9/7/05)

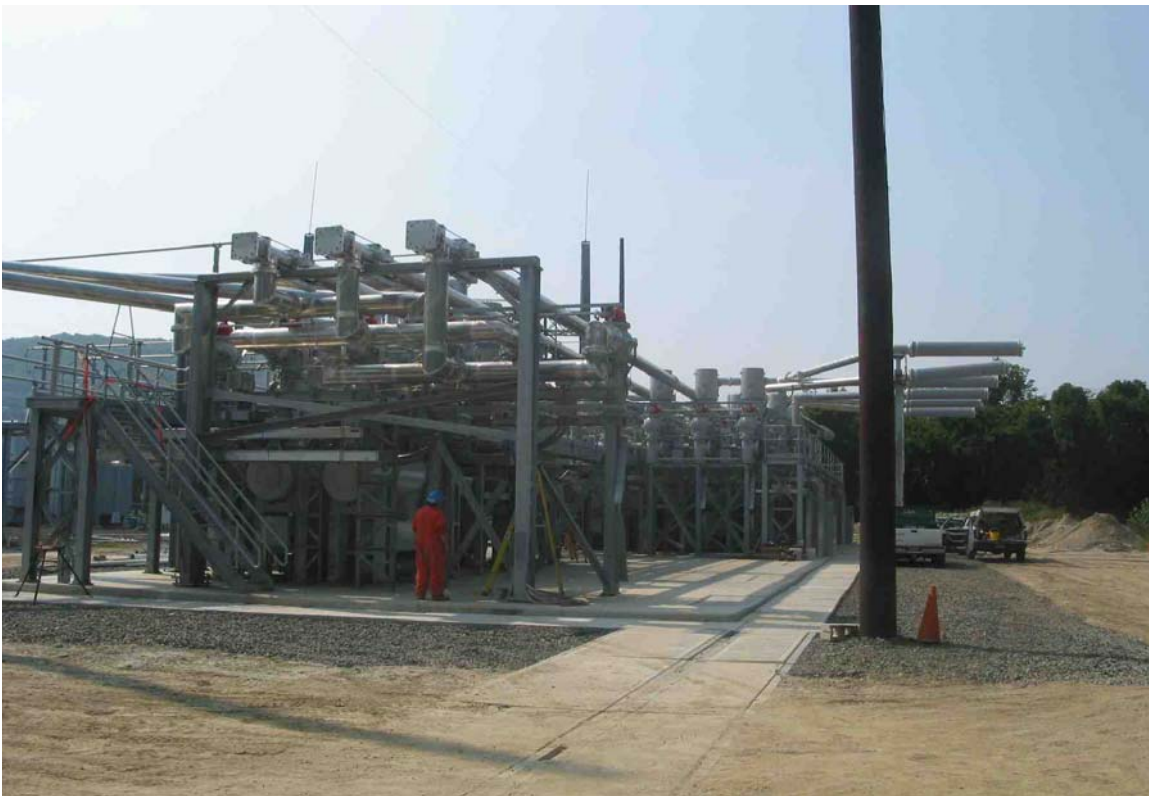
Plumtree Substation: Stone was recently placed around the perimeter of the concrete pad. (9/7/05)
